Advantage
Inspection

Inspection Report

10.26.2010

722 Sunny Forest Lane
Raleigh NC 27605

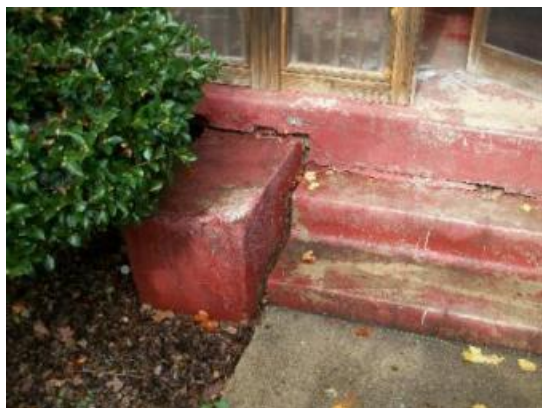
The concrete end of the front steps has settled leaving a gap between the steps and the end cap. The steps are not affected by this settlement.

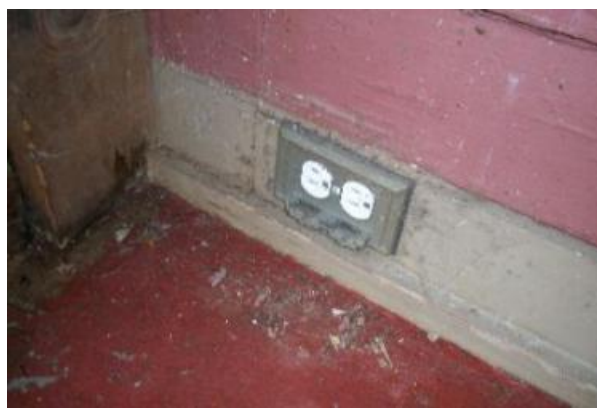
The front porch electrical receptacle is missing the weather protective cover and is not GFCI protected.

16. Exterior electrical outlet at the front and rear of the house is not properly covered. See photo. All exterior outlets should have waterproof covers installed on them in order to prevent moisture from causing ground fault circuit to trip and provide protection for personal safety when not in use.

Recommend professional electrical contractor repair/replace as necessary.

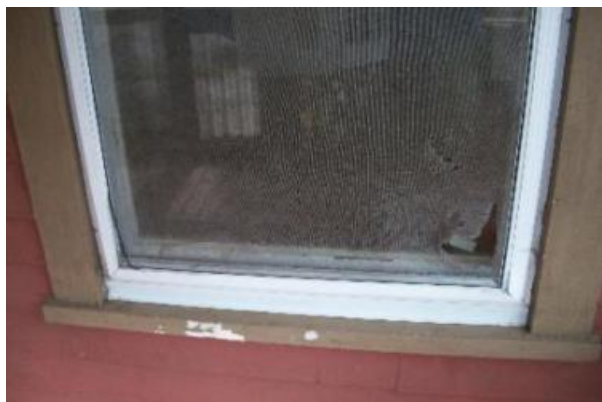
Torn window screen at the front porch

- 3. The wood siding paint is peeling and flaking off. Recommend professional painter evaluate wood siding and repair and repaint as necessary.
4. Observed some window screens that are damaged/torn and need repaired/replaced. Check all windows and repair/replace damaged or missing screens where necessary.

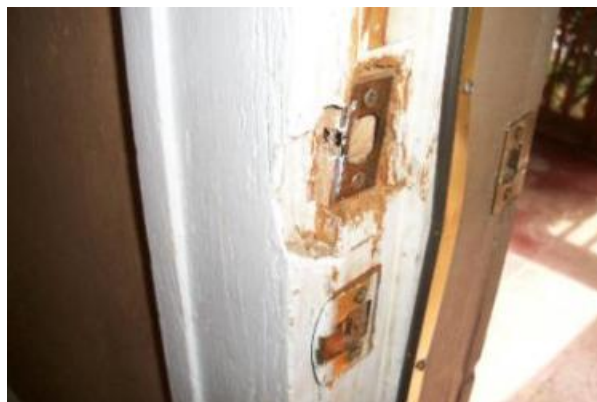
The front door jam has a lot of damage where the dead bolt secures the door.

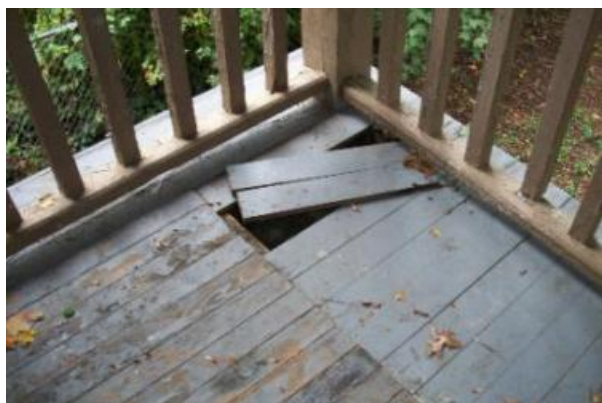
The rear elevated porch has wood damage and loose or missing boards as well as a low railing and the flooring of the porch is sloping downward towards the backyard. Recommend a General contractor or a Structural Engineer evaluate the rear porch.

7. Peeling paint on the driveway side. Recommend professional painting contractor scrap and repaint where necessary.
8. The front porch door rubs the concrete floor. Recommend professional contractor repair/replace as necessary to allow proper function of the door. The rear elevated porch has wood damage and loose or missing boards as well as a low railing and the flooring of the porch is sloping downward towards the backyard. Recommend a General contractor or a Structural Engineer evaluate the rear porch.

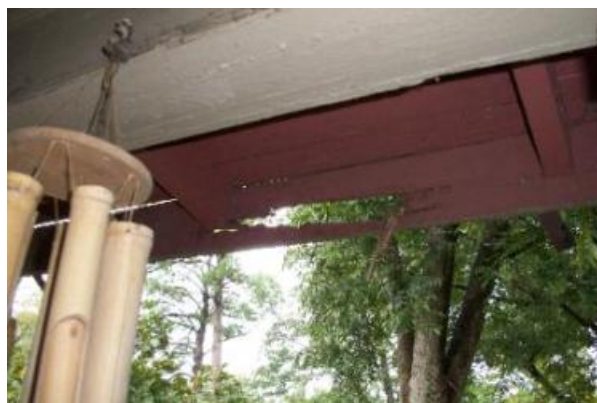
Backside view of the fascia board wood decay

9. There is wood decay to the fascia board all along the back and the corners of the house. Recommend professional contractor replace decayed wood fascia board and seal/paint.

FASCIA- Wood
There is wood decay to the fascia board all along the back and the corners of the house. Recommend professional contractor replace decayed wood fascia board and seal/paint.

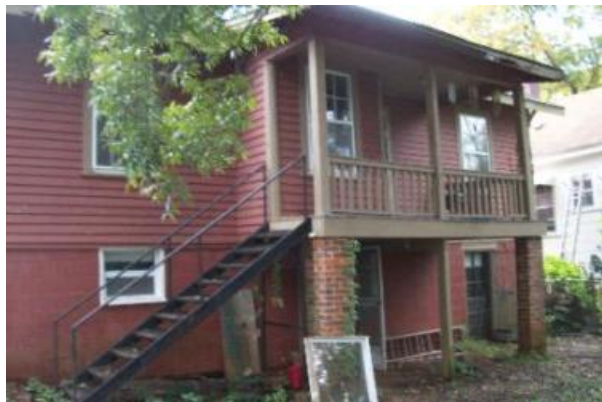
View of the rear porch with the metal stairs

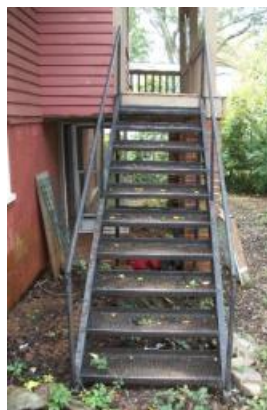
The rear porch view from the stairs side shows the slope towards the backyard

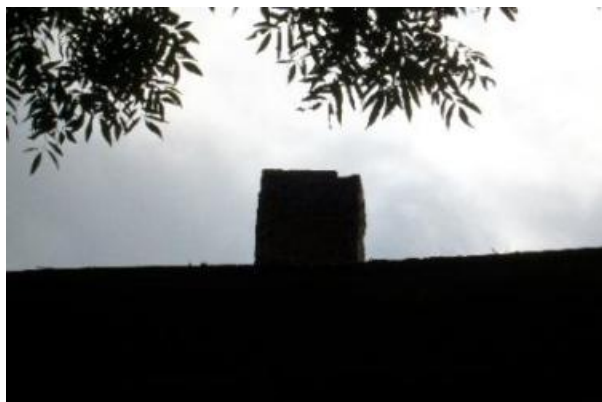
The Chimney is missing has loose and missing bricks at the top and no chimney cap could be observed. Recommend a chimney professional be consulted for further evaluation

21. Loose bricks observed at the top of chimney for fireplace. Fireplace was visually inspected only, not tested. It is recommended that a qualified chimney sweep complete a full evaluation of the inaccessible areas of the smoke shelf, flue and chimney cap as part of the inspection process before purchase and at each seasonal operation.

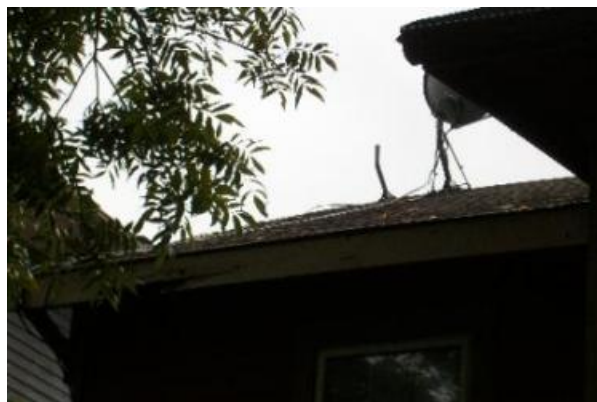
The cables from the Dish are laying on the shingles across the roof

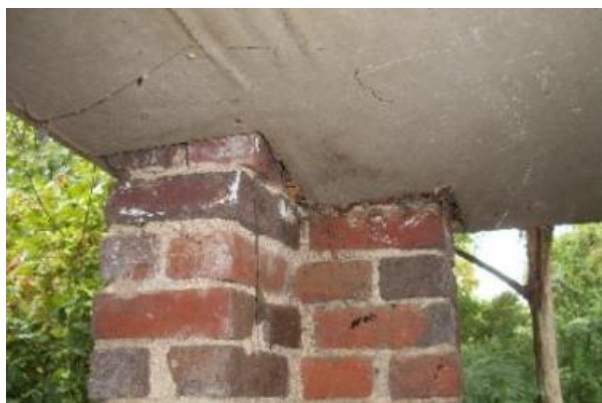
The under side of the rear porch shows signs of water damage where the boards are missing above

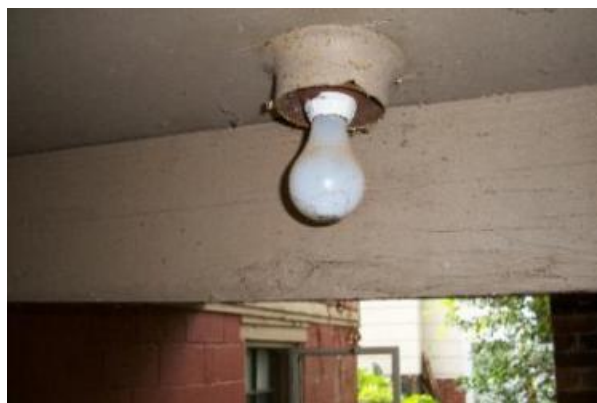
The exterior light under the back porch is missing the globe to protect the light bulb

15. Globes are not installed . Install proper globe that protects bulb against adverse weather conditions and individual against bulb burst in the event of a failure. The middle switch on the living room wall operates both the ceiling fan in the living room and the ceiling fan on the front porch at the same time. Both fans are wired to the same switch. Recommend professional electrical contractor evaluate and repair/replace as necessary.

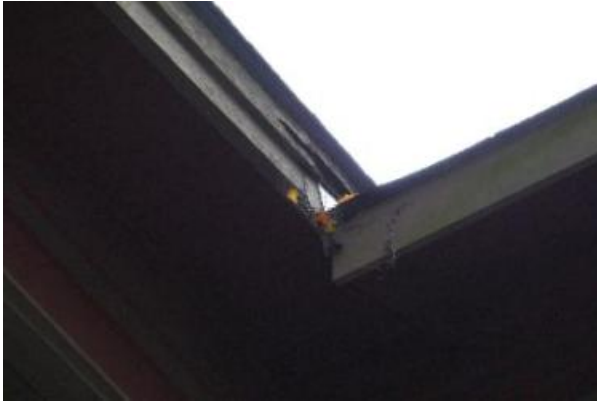
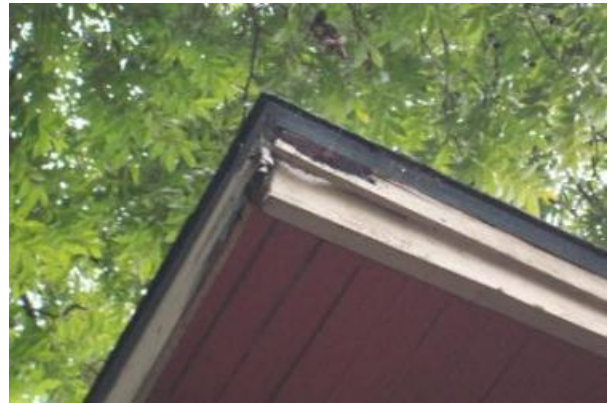
Facia damage

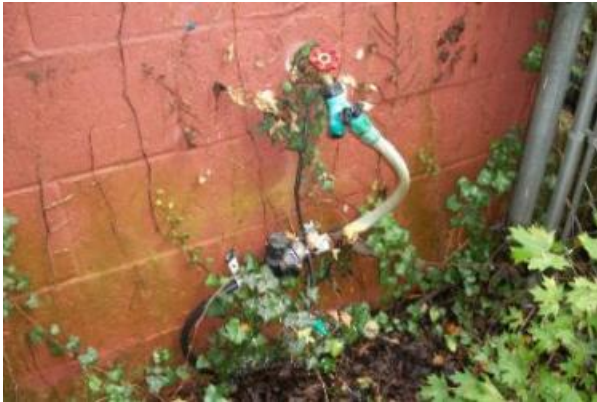
The exterior rear hose bib is leaking

- 12. Rear hose faucet leaking - Recommend professional plumbing contractor repair or replace.

Rear hose faucet leaking - Recommend professional plumbing contractor repair or replace.

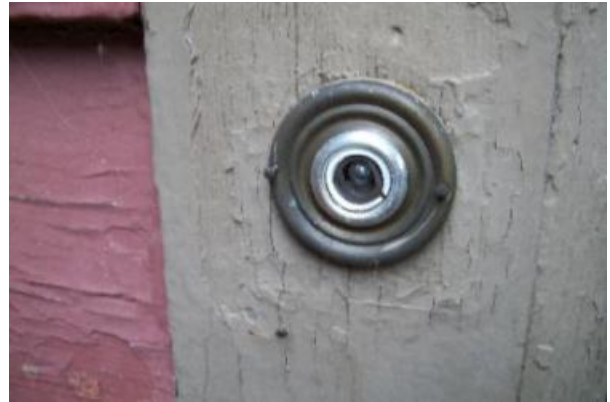
Rear door bell switch is broken

18. Rear door door bell button is broken but operational. Push button is cracked and personal injury is at risk when this door activation device is pressed. Recommend professional contractor replace broken push button at the rear door.

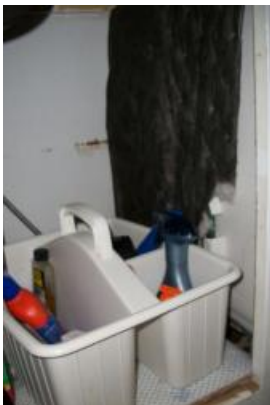
The is no cabinet wall between the dishwasher and the kitchen sink. This can allow for items places in the cabinet to fall into the dishwasher area and make their retrieval very difficult

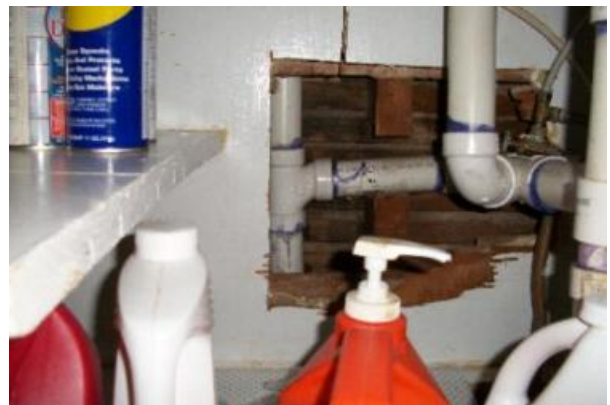
The cabinet under the kitchen sink has the back cut away exposing the interior of the wall this may have been done when there was work done to the plumbing drain system. Also this shows that the plumber has completely cut through the wall stud

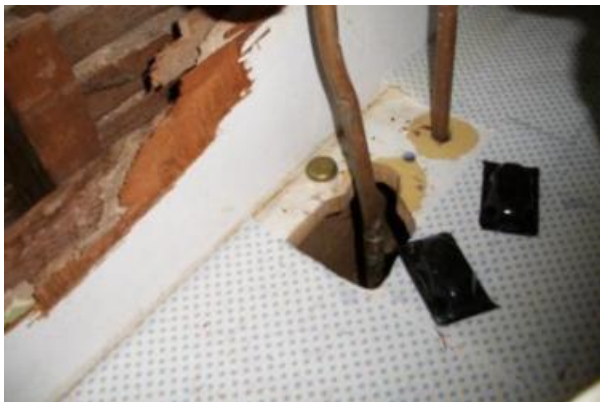
The holes under the kitchen sink need to be closed to prevent unwanted animals from entering.

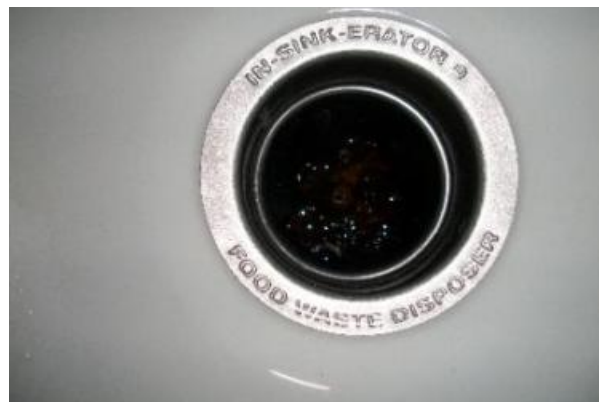
Splash guard that protects operator from contents being through from the appliance during operation located in the throat of the sink drain is deteriorated and needs to be replaced.

30. Splash guard that protects operator from contents being through from the appliance during operation located in the throat of the sink drain is deteriorated and needs to be replaced.

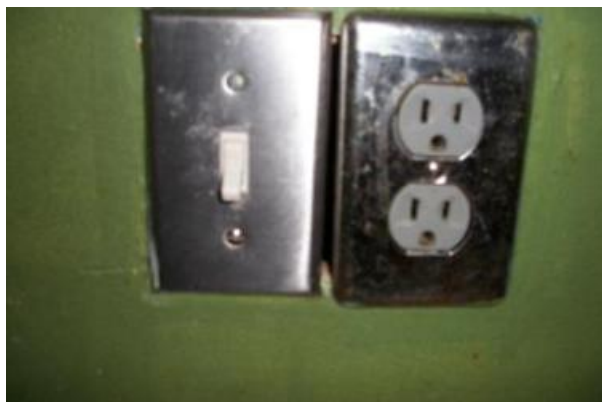
The outlet box in the kitchen is a two gang box that requires a single cover this has two single covers leaving a space between the two.

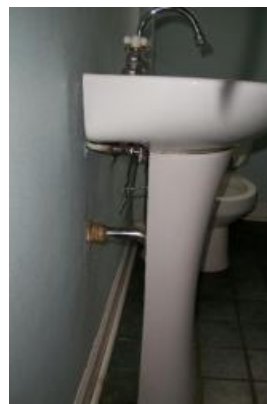
The bathroom pedestal sink is free standing

- 13. Lavatory pop up assembly is defective, needs repair. The pedestal sink is not properly secured to wall. Toilet is loose to floor flange and leaking could occur- needs to be tightened. Recommend professional plumbing contractor repair/replace as necessary.

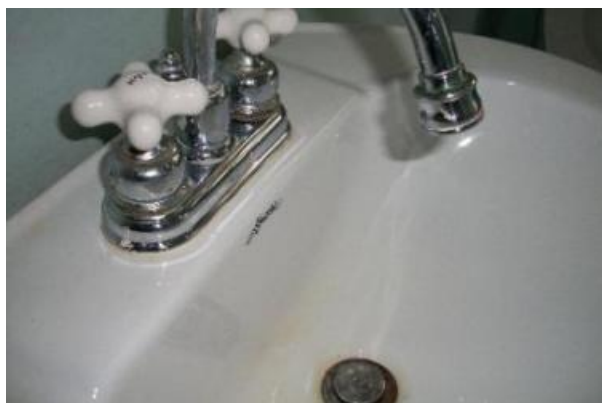
The bathroom sink faucet stopper does not function as intended

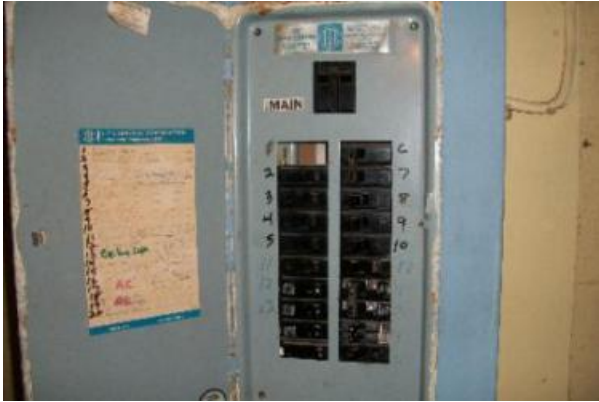
The electrical panel box is missing a blank cover plate at the number one position

19. The electrical panel box is missing a blank cover plate at the number one position and at the side knockout. Recommend professional electrical contractor replace missing cover plate.

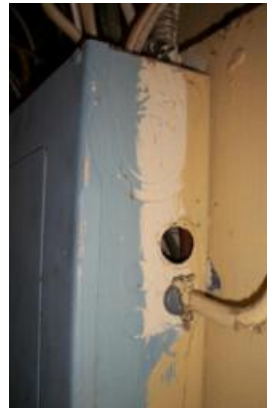
The electrical panel box is missing a cover plate at the side knockout

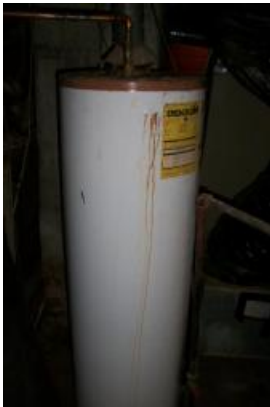
The water heater is rusting at the sides, expect to replace it in the very near future

The water heater was inspected and operated as expected at the time of the inspection. The water heater is rusting at the sides, expect to replace it in the very near future

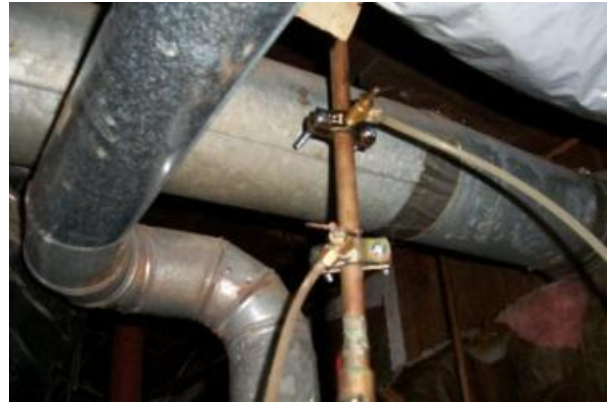
Observed saddle tap water connection that is being used for the water supply HVAC humidifier. Saddle taps are known to be problematic and to have small leaks over time. Suggest monitoring this water connection for leaks and replace with hard pipe

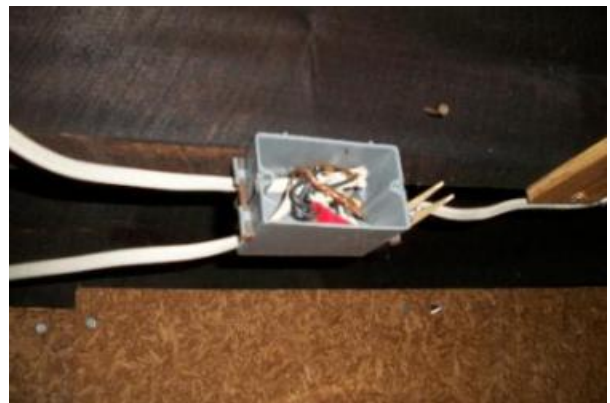
Missing cover

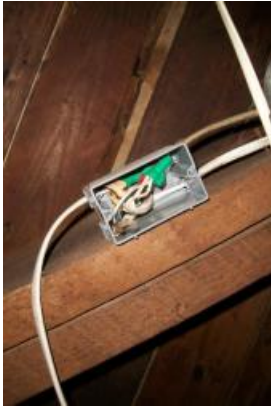
Missing cover

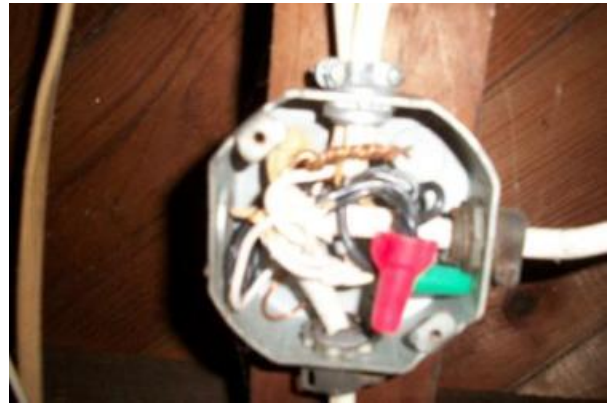
Missing cover

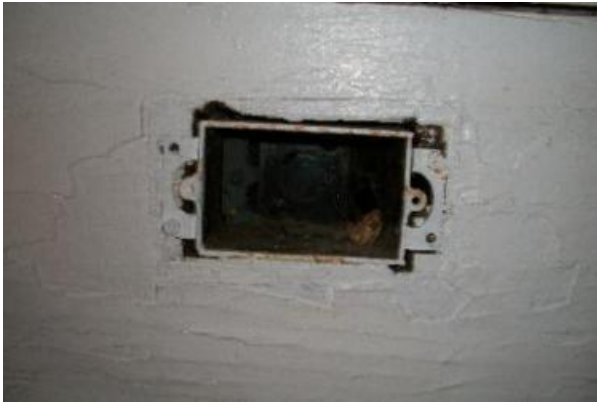
Missing cover

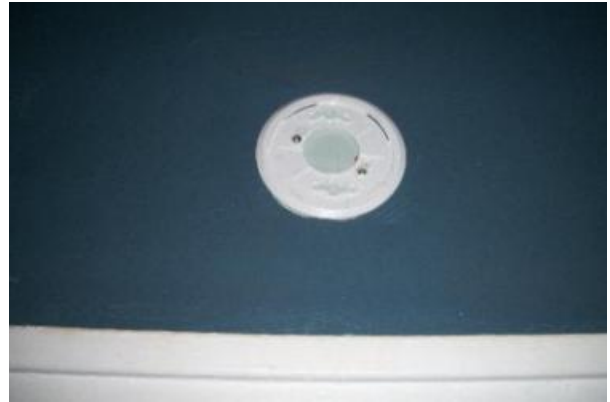
Missing smoke detector

17. Smoke detector was not installed. It is recommended that a carbon monoxide detector be installed with use of gas, propane or wood burning appliances. Recommend professional contractor install smoke and carbon monoxide detectors.

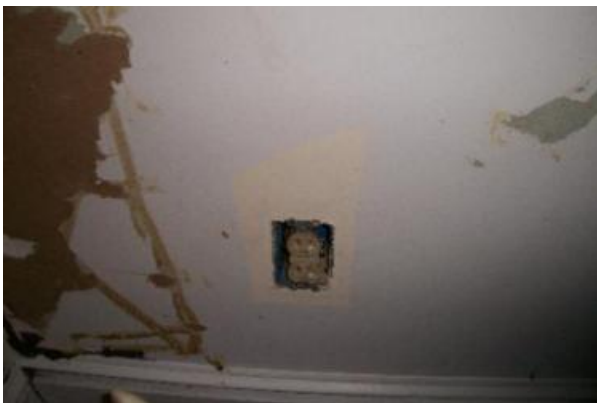
Missing cover plate

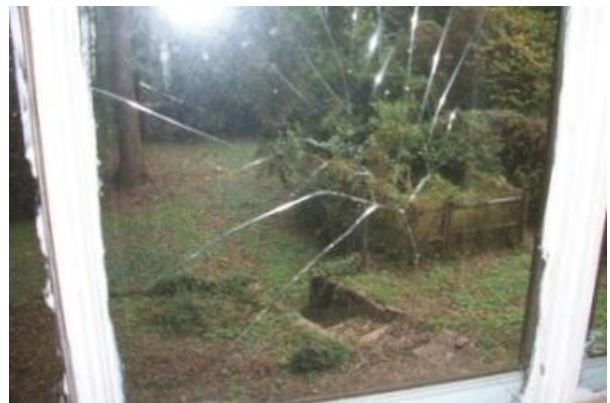
Broken Glass

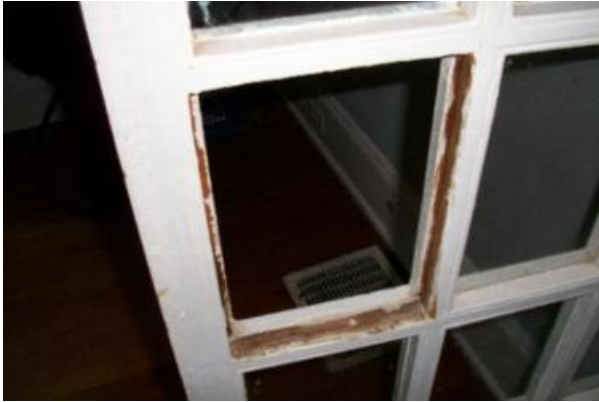
Missing Glass between the Living and Dining rooms

24. Front bedroom door does not latch in the closed position. Recommend professional contractor adjust/repair door. Missing Glass between the Living and Dining rooms. Recommend replacement of glass.

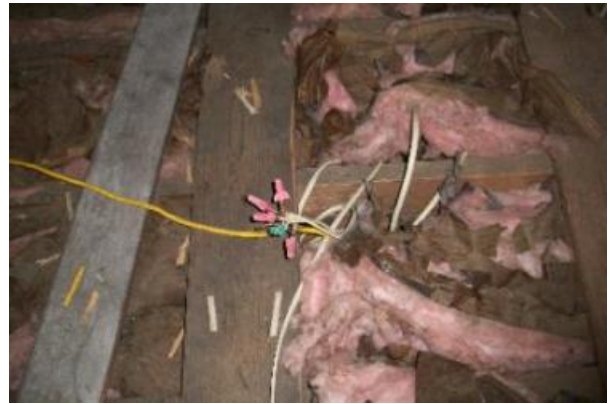
Electrical wires need to be connected inside of a junction box

- 14. Many wire splices not in proper protective boxes and boxes without proper covers Recommend a licensed Electrical contractor repair or install proper cover plates

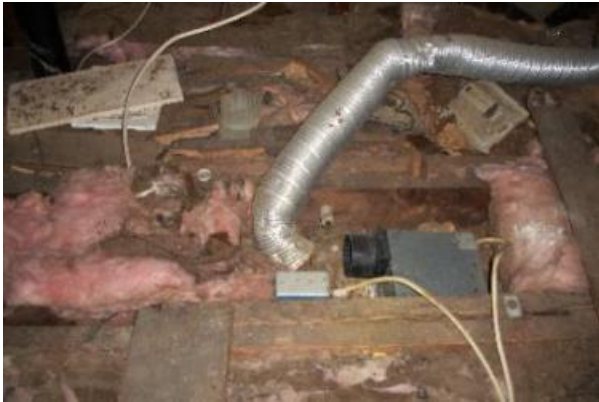
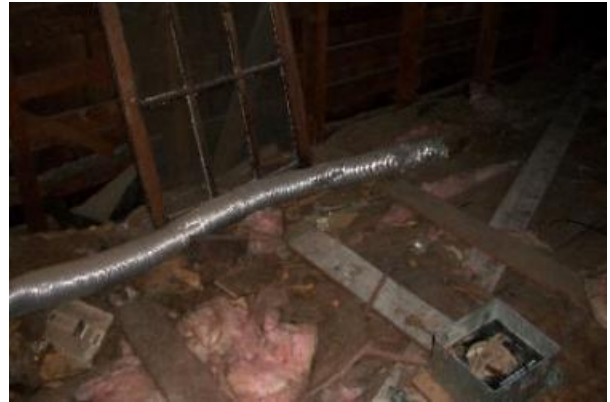
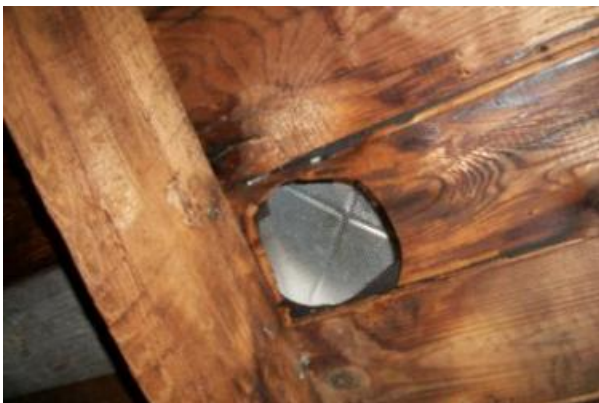
The exhaust fan vent pipe from the bathroom is disconnected in the attic

28. The exhaust fan vent pipe from the bathroom is disconnected in the attic. Recommend professional contractor reconnect vent pipe to insure proper function of the exhaust fan.

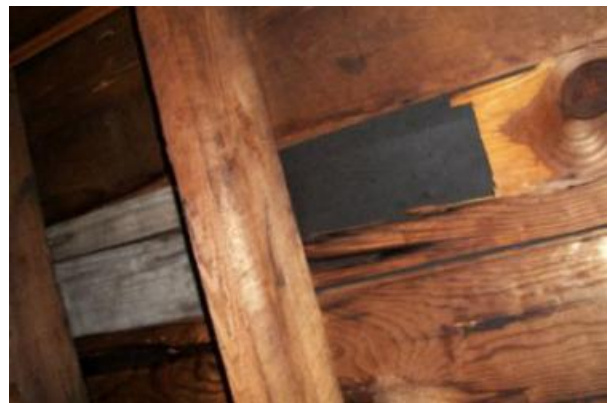
Missing roof sheathing at the left rear towards the top

Missing roof sheathing at the left rear towards the top. Recommend professional contractor repair/replace as necessary.

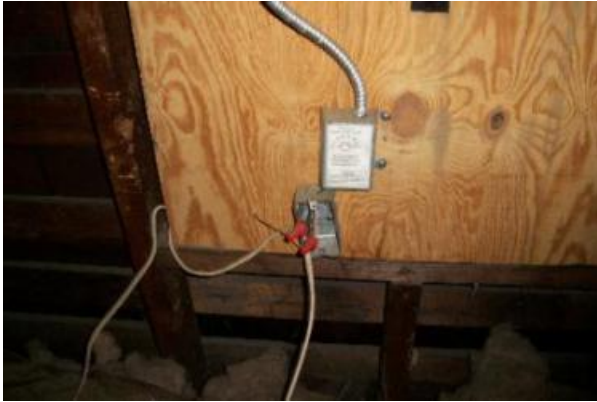
Missing cover

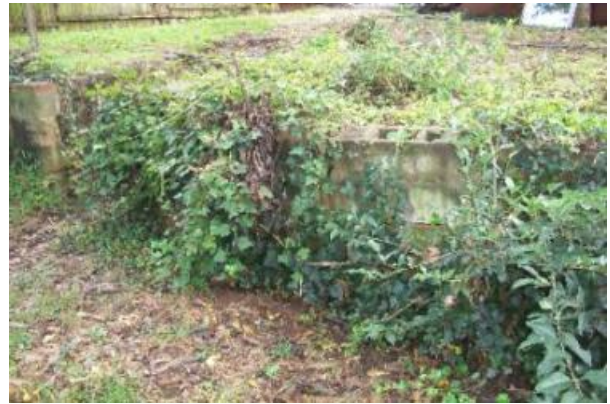
The backyard retaining wall is leaning over
recommend a structural engineer evaluate.

10. Cracking observed in retaining wall as well as tipping and/or displacement. Retaining wall that is perpendicular to the rear wall of the foundation at the center rear section of the house has been exposed to hydrologic pressure as well as grade settlement over time that have resulted in movement of the retaining wall. There does not appear to have been a water relief drain line installed that helps relieve pressure form saturated ground water. Recommend that this wall be evaluated by a structural engineer in order to determine if repairs are necessary to stabilize this retaining system.

RETAINING WALLS- Concrete Block
Cracking observed in retaining wall as well as tipping and/or displacement. Retaining wall that is perpendicular to the rear wall of the foundation at the center rear section of the house has been exposed to hydrologic pressure as well as grade settlement over time that have resulted in movement of the retaining wall. There does not appear to have been a water relief drain line installed that helps relieve pressure from saturated ground water. Recommend that this wall be evaluated by a structural engineer in order to determine if repairs are necessary to stabilize this retaining system.

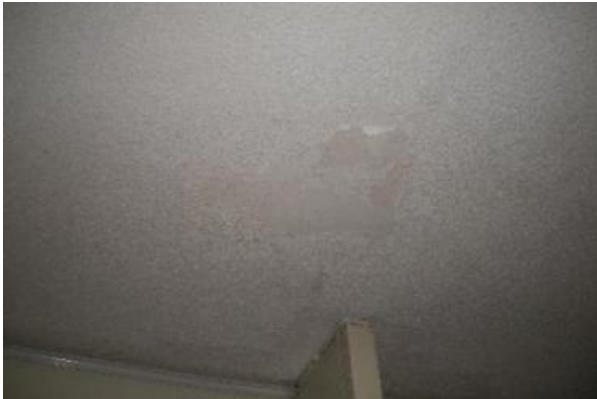
The ceiling in the kitchen shows signs of a previous
water intrusion which now appears to be inactive at
this time

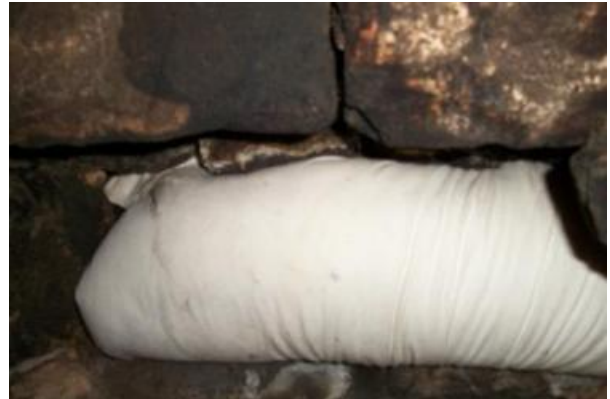
The Chimney is stuffed with foreign objects

20. Fireplace was visually inspected only, not tested. Inside of chimney flue for fireplace could not be inspected due to being stuffed with pillows. Recommend removal of pillows and have professional inspect chimney flue.

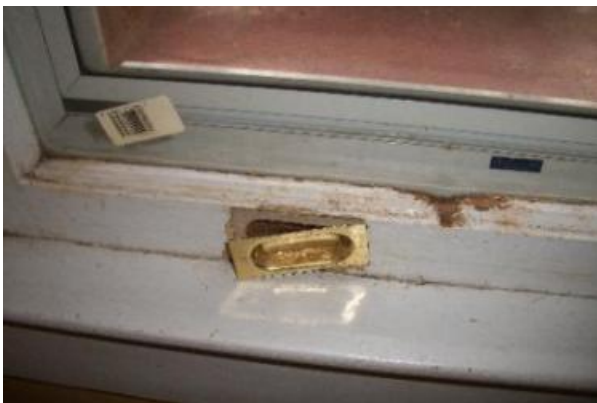
Windows are in need of repair to make them fully
functional for example the ropes and weights, glass,
hardware

26. Windows are in need of repair to make them fully functional for example the ropes and weights, glass, hardware. Recommend professional contractor evaluate windows for repair/replacement to allow proper function.

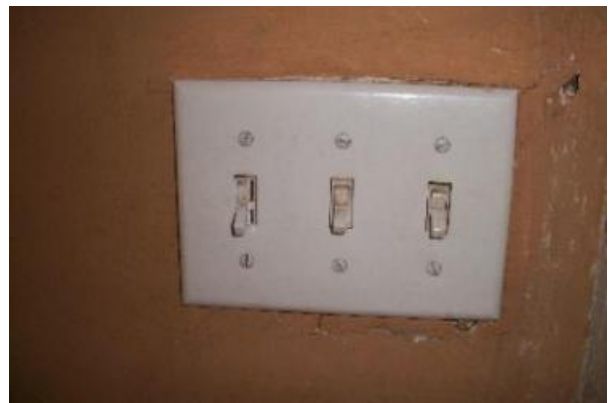
The middle switch on the living room wall operates
both the ceiling fan in the living room and the ceiling
fan on the front porch at the same time. Both fans
are wired to the same switch

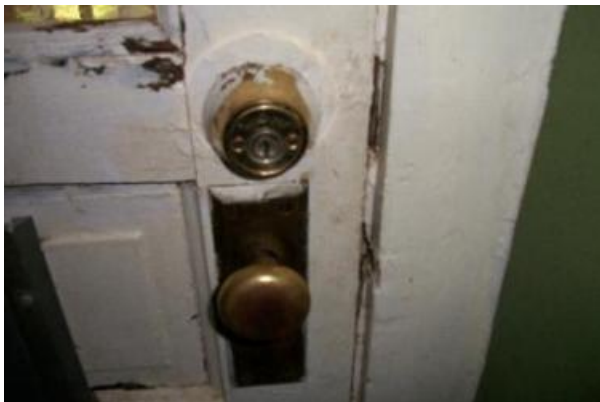
The back door from the kitchen does not latch in the closed position and there is no threshold to the door, The wood floor goes right under the door and stops 2" outside. Recommend replacement of the door by a professional contractor

6. The back door from the kitchen does not latch in the closed position and there is no threshold to the door, The wood floor goes right under the door and stops 2" outside. Recommend replacement of the door assembly by a professional contractor.

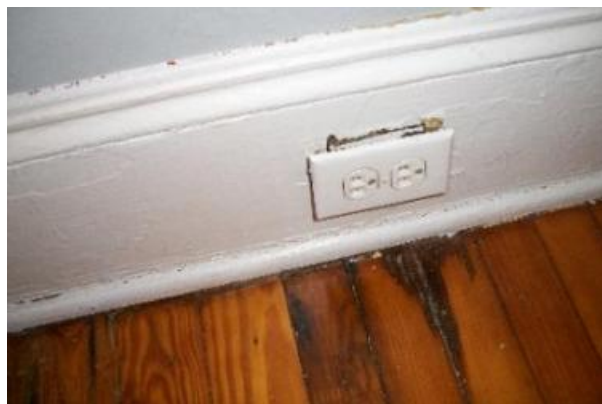
Loose Receptacle box in the front bedroom

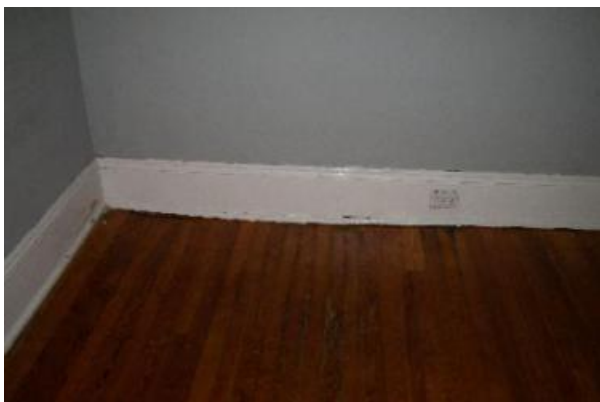
The front bedroom floor has a large dip along the common wall with the bathroom

Materials and Installation typical for construction period. The front bedroom floor has a large dip along the common wall with the bathroom. Recommend professional contractor evaluate and repair as necessary.
